NBSIR 75-647

Mechanical Tests of FAA-E2491 Airport In-Pavement Approach and Threshold Lights

**Engineering Mechanics Section
Mechanics Division
Institute for Basic Standards
National Bureau of Standards
Washington, D. C. 20234**

**Prepared for
Federal Aviation Administration
Washington, D. C. 20590**

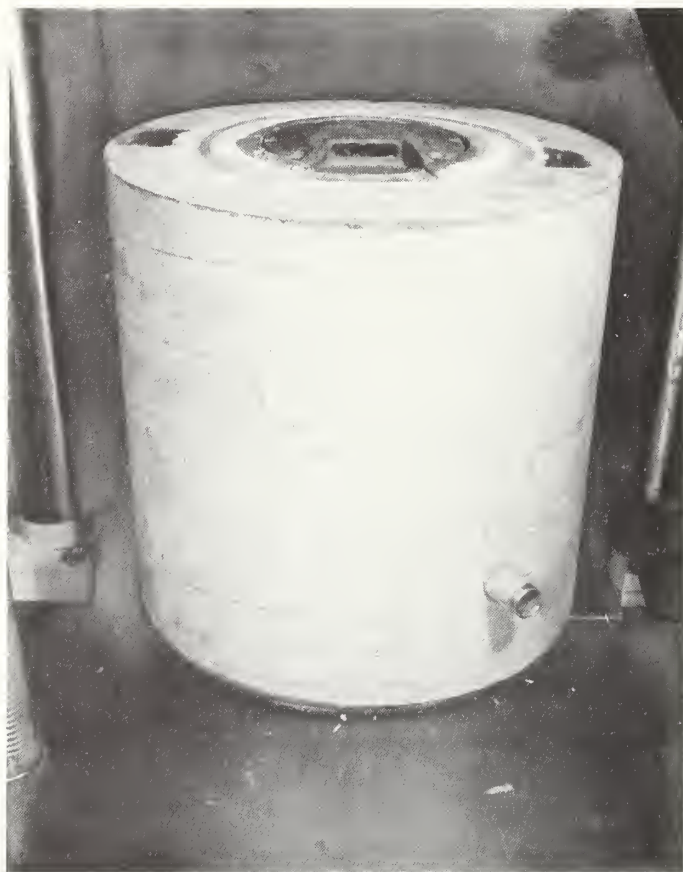
**Figure 2 — Type FAA-E-2491 Airport Marker Light Installed
in LB-4 Base Encased in Concrete Cylinder**

A schematic of a light unit installed in the LB-4 base encased in a concrete cylinder is shown in Figure 1 and a photograph showing the exposed optical cover assembly and adapter ring for the installed light is given in Figure 2.

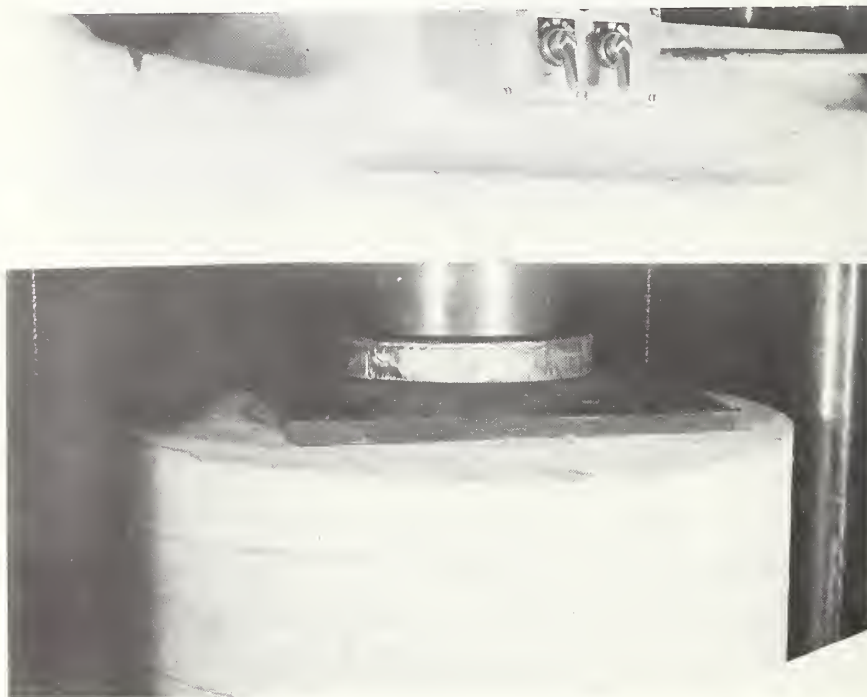
Figure 5 — Static Test Setup Using Rubber Pad for Loading Top of Light Assembly

The static load tests were performed in a 400,000 lbf capacity universal testing machine. The LB-4 light base encased in concrete was placed on a 36-inch diameter by 0.75-inch piece of plywood to protect the machine platen. All of the lights were installed in accordance with procedures given in Reference 2. Static loads were applied using either a 6-inch diameter by 1½-inch thick steel plate or using a rubber pad having a Shore A hardness of 55 to 65 through which the loads were transferred to the cover assembly. Figure 4 shows the set-up when using the 6-inch diameter plate. When the rubber pad was employed, it was compressed by a large steel plate which overlapped the top of the optical cover assembly, as shown in Figure 5.

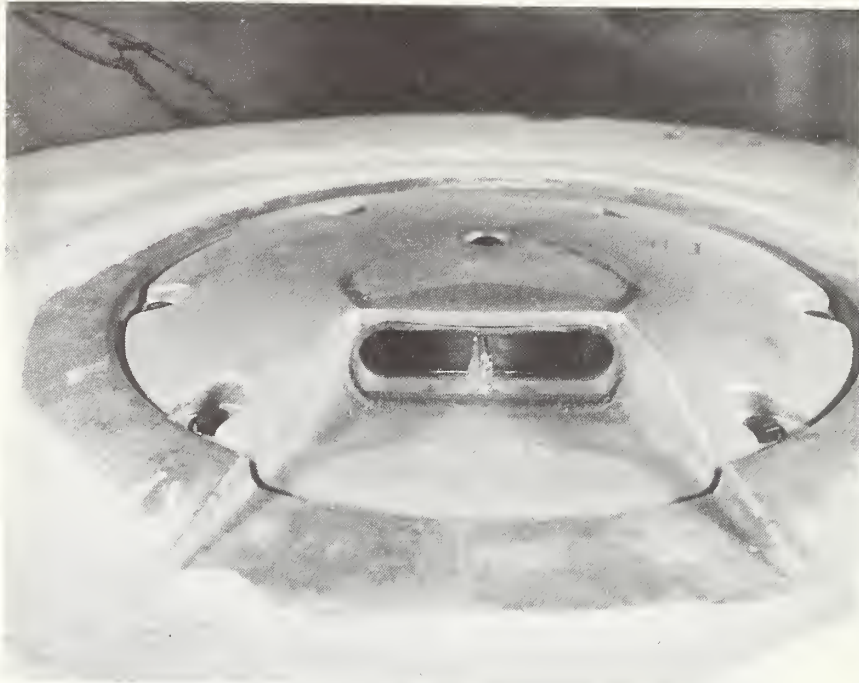
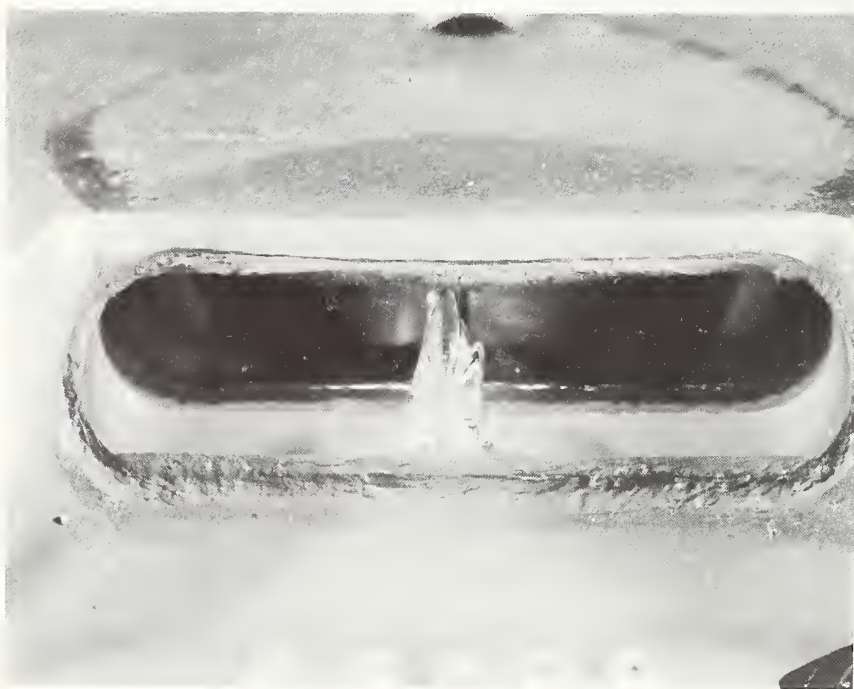
Figure 7a — Prism Fracture Developed During Static Test of New Style FAA-E-2491 Light

Figure 7b — Closeup of Prism Fracture in New Style FAA-E-2491 Light

The principal results of the static load tests are summarized in Table 1. All of the tests on the new style lights were terminated when the glass prism in the optical cover assembly fractured. These fractures all occurred in the center of the prism, as shown in Figures 7a and 7b. The load versus deflection of the optical cover assembly measured when the lights were loaded through the 6-inch diameter steel plate and through the rubber pad is plotted in Figure 8. The strains measured on the cover assembly during these tests are shown in Figures 9 and 10 and the strains measured on the glass prism are plotted in Figure 11. The measured deflection and strain levels at a given load were generally higher for the distributed load (rubber pad) tests than for the concentrated load (steel plate) tests on the new style lights.

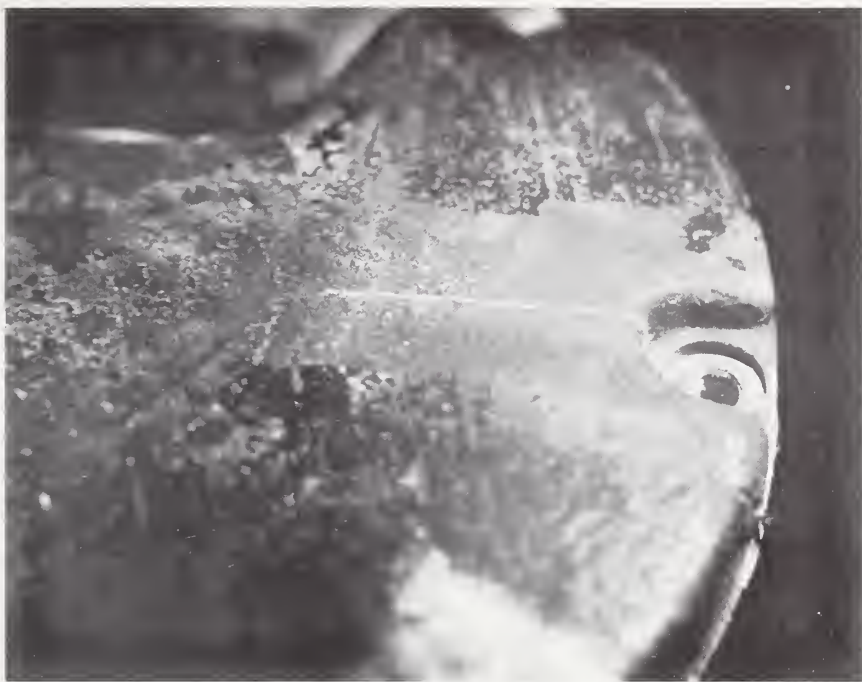
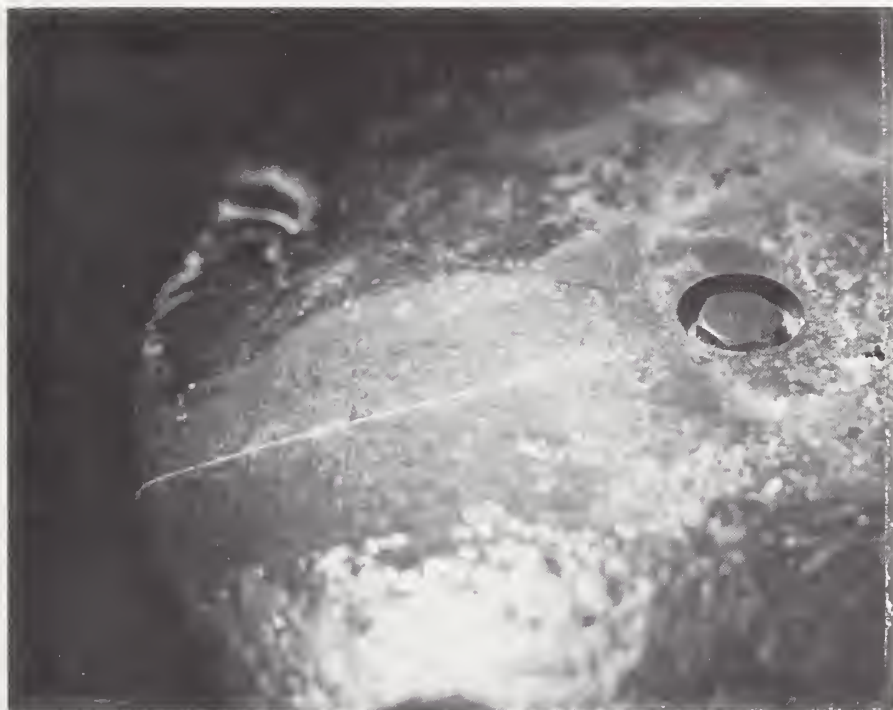
**Figure 12 — Fracture of Optical Cover Assembly of Old Style FAA-E-2491
Light After Static Test Using 6-Inch Diameter Steel Plate**

During the test on the old style light, Serial No. 267, when the load was applied to the optical cover assembly by a steel plate, the glass prism was displaced from its initial position in the cover assembly and the test was terminated when the cover assembly casting fractured at a load of 316,500 lbf. After this test, the paint was removed from the cover assembly and dye penetrant was sprayed onto the fractured surface. Photographs of the cracks were then taken when the cover assembly was exposed to an ultra-violet light source. Figure 12 shows the two principal fractures which emanated from the topmost surface of the cover assembly and propagated to the edge of the casting.
